DEPARTMENT OF TRANSPORTATION**DIVISION OF ENGINEERING SERVICES**

Contract #: 04-0120F4Cty: SF/ALA Rte: 80 PM: 13.2/13.9File #: 69.28**WELDING INSPECTION REPORT****Resident Engineer:** Pursell, Gary**Address:** 333 Burma Road**City:** Oakland, CA 94607**Report No:** WIR-000687**Date Inspected:** 18-Oct-2007**Project Name:** SAS Superstructure**OSM Arrival Time:** 630**Prime Contractor:** American Bridge/Fluor Enterprises, a JV**OSM Departure Time:** 1500**Contractor:** Zhenhua Port Machinery Company, Ltd (ZPMC), Changxing Island **Location:** Shanghai, China

Bridge No: 34-0006**Component:** OBG U-Rib Trial Assy**Summary of Items Observed:**

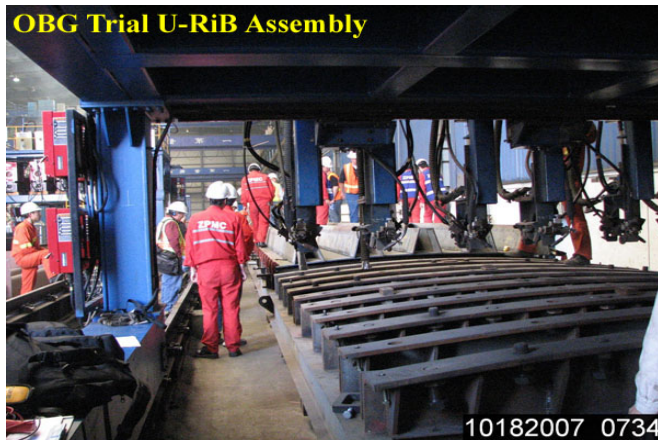
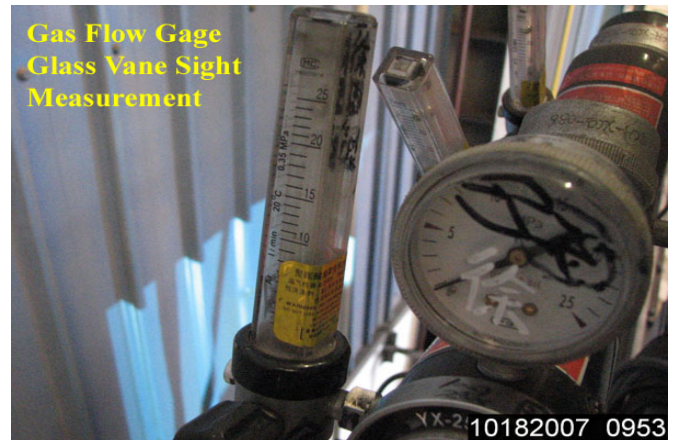
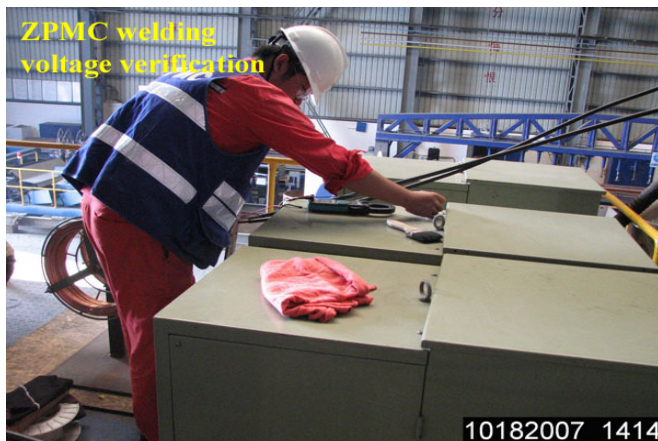
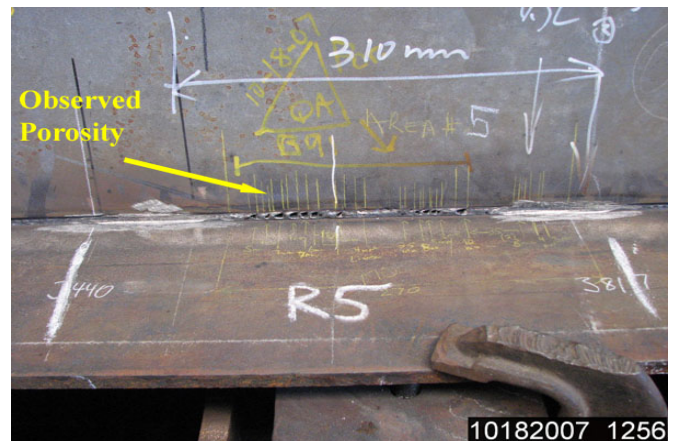
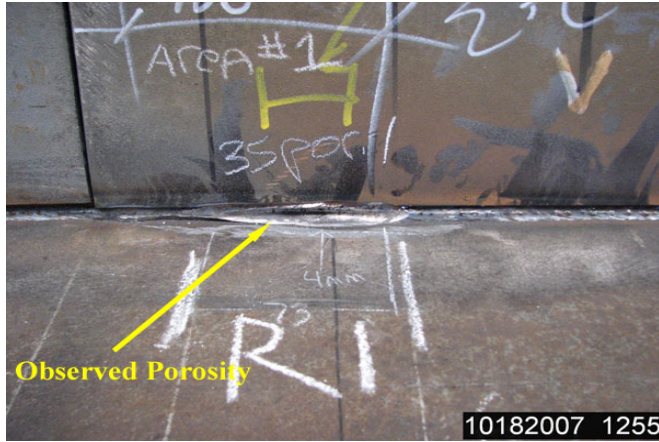
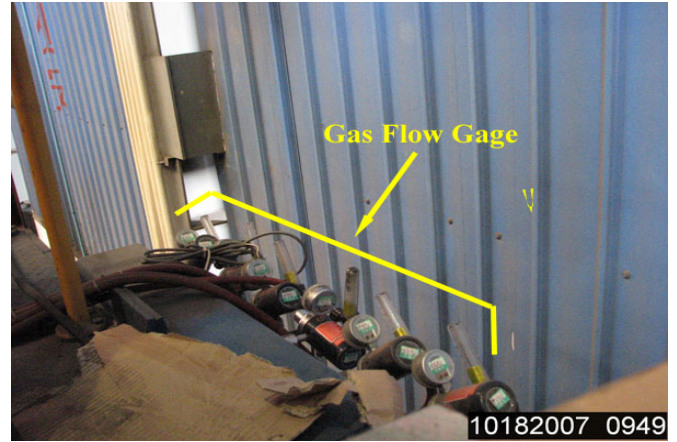
The root passes were then visually inspected for conformance. U-rib #U71, weld 10 appeared to have porosity, starting at the hand-hole end and ending at the 5764 mm mark on the u-rib. Five locations were identified and length measured as follows.

U-Rib #71 Weld 10	Porosity	Location	Length
R1	X	170-253mm mark	83mm
R2	X	1038-1395mm mark	357mm
R3	X	1640-1720mm mark	80mm
Stop/Restart		1947mm mark	
R4	X	2235-2320mm mark	85mm
R5	X	3440-3817mm mark	377mm

These locations were marked by ZPMC for further evaluation. Following digital pictures illustrate welding activities and observed porosity.
